Rapid Airfield Damage Repair (RADR) Program

# Modified Light-Duty AM2 Capability Assessment

## **Modified Light-Duty AM2 Capability Assessment**

#### Final report

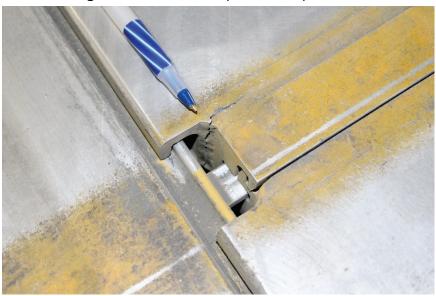
Trafficking of the C-17 test item began 10 February 2017. The first damage noted on the Modified Light-Duty AM2 surface was at pass 240. Panels C5, C6, C12, C13, C33, and C34 all displayed short (1 in. or less) cracks originating from the corner fusion weld along the overlap/underlap connector and traveled along the friction stir weld on the top skin, as shown in Figure 14.

Figure 14. Corner crack in panel C13 at pass 240.

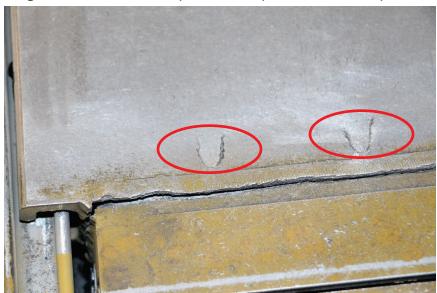
At pass 480, the cracks in panels C5, C6, C12, C13, C33, and C34 continued to propagate along the friction stir weld on the top skin. Panels C20, C27, and C28 also developed the same cracks along the friction stir weld. Panel C33 had the longest crack of all the panels, measuring 6 in. Figure 15 reveals where the top skin began to tear away from the end of the vertical stiffeners on panel C33.

Figure 15. Weld crack and top skin tears in panel C33 after 480 passes.

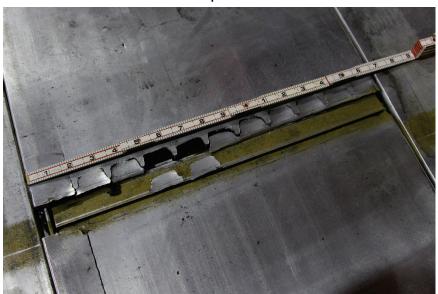
Traffic was stopped at pass 660 after the crack in the friction stir weld in panels C5, C27, and C33 had propagated along the full length of the overlap/underlap connector and detached the connector from the core of the panel; therefore, each of these panels were considered failed. Additionally, the top skin tore around the end of each vertical stiffener as well as along the female hinge connector of panel C33. Figure 16 is a photograph of the damage to panel C33. New damage was recorded in the form of a 3 in. top skin tear along the female hinge connector for panel C6.

Figure 16. Overlap/underlap connector damage on panel C33 after 660 passes.

The area of the three damaged panels was 14.0% of the trafficked area, exceeding the 10% mat breakage damage criterion; therefore, the C-17 test item was considered failed. Traffic was stopped at the next scheduled data interval of 768 passes to record final survey data. At pass 768, a fourth panel had failed due to breakage in the same manner as the first three. Table 7 provides a summary of the mat breakage within the C-17 test item.

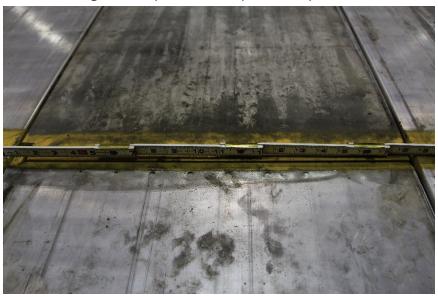
Trafficking of the F-15E test item began on 14 February 2017. The first damage recorded was at pass 48. Panels F5, F6, F12, F13, F19, F20, F26, F27, F33, and F34 were all beginning to tear the top skin around the end of the vertical stiffeners beside the overlap/underlap connector. A photograph of the damage to panel F6 is shown in Figure 17.

Figure 17. Top skin tears on panel F6 at pass 48.

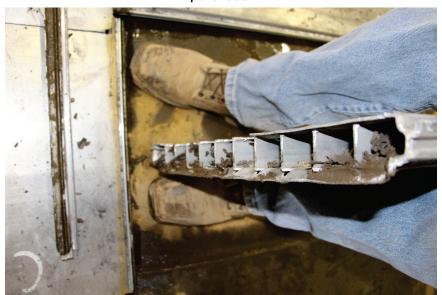
The C-17 test item sustained 660 passes of simulated traffic before failing due to mat breakage. The main failure mode was crack propagation in the weld between the overlap/underlap connector and the mat core along the centerline of the test item. The cracks began on the fusion weld between the overlap/underlap connector and the female hinge connector and then propagated up and along the friction stir weld. Upon removal of the trafficked C-17 panels, it was noted that the overlap/underlap connectors on panels C<sub>5</sub>, C<sub>27</sub>, and C<sub>33</sub> were completely sheared off from the core of the mat, as shown in Figure 33. Additionally, after the weld cracks were recorded, a couple of the damaged panels revealed cracking around the end of the vertical stiffeners next to the overlap/underlap connector. Finally, three panels exhibited top skin tears along the female hinge connector. Panels C9, C16, C23, C30, and C37 all had large cracks in the center of the female hinge connector (Figure 34), which was documented upon removal. Panel C2 was the only center panel that did not exhibit a crack within the female hinge connector.

Figure 33. Complete separation of the overlap/underlap connector on panel C33.

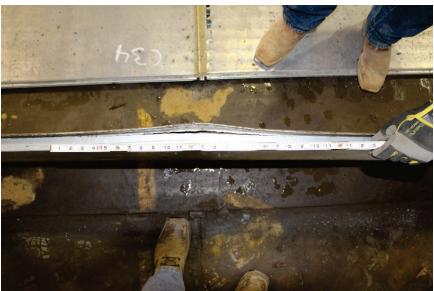
Figure 34. Female hinge connector crack in panel C37.

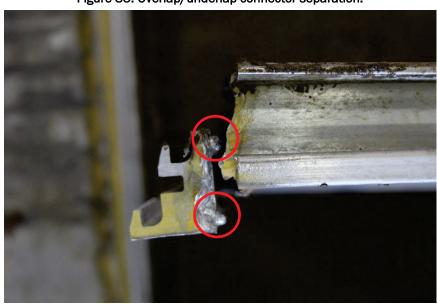
It was inferred that the overlap/underlap connector failures occurred because of the design for the connector's attachment to the core. A photograph and a sketch of the overlap/underlap connector design are shown in Figures 35 and 36, respectively. The small tabs (shown in red) give support for the friction stir weld; however, there is no additional

support between the overlap/underlap connector and the core of the mat. With only the top and the bottom skins to transfer the load between the connector and the core, large amounts of plastic deformation occurred, and cracks propagated quickly through the welds. The Modified Light-Duty AM2 connection was designed differently than AM2 in order to meet the 4.0 lb/ft² weight requirement for RPA matting. If the connection between the overlap/underlap connector and the core were improved, the matting system would likely provide better performance; however, cracks in the female hinge connector would continue to be a concern.

Figure 35. Overlap/underlap connector separation.

Modified Light-Duty AM2 in its current design should not be used for contingency C-17 or reduced F-15E traffic. It is recommended that the connection between the mat core and the overlap/underlap connectors be redesigned before further consideration of Modified Light-Duty AM2 as a lighter-weight replacement for standard AM2. Regardless, Modified Light-Duty AM2 should be considered as a viable solution for RPA and similar traffic, such as vertical takeoff and landing (VTOL) operations.
